Manhole Inspection Summary

Manhole # S51M__017MH

Insp Date: **4/10/08 3:07 PM**

Location Address: **903 Binney St**

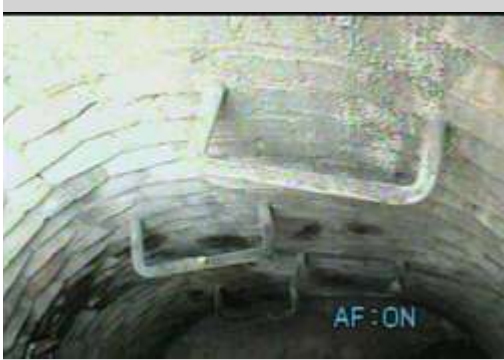
Defect 4

Count: **4** Missing: **0** ☒ **Corroded**

corroded stairs

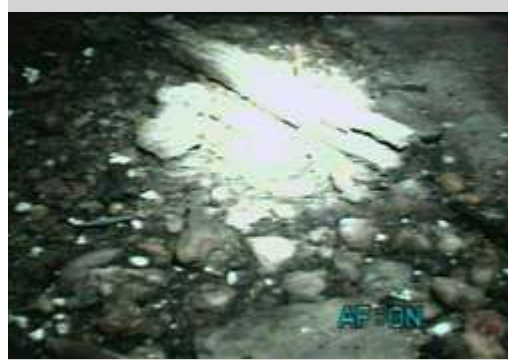
Defect 3

Condition: ☐ Sound ☐ Cracked ☐ Root Intrusion ☐ Deteriorated ☐ Leaks ☒ **Debris**

channel debris

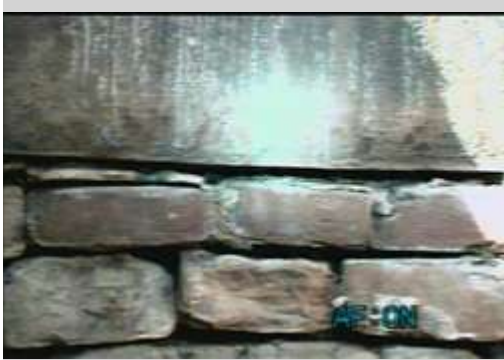
Defect 2

Condition: ☐ Sound ☐ Cracked ☐ Root Intrusion ☒ **Loose Brick** ☐ Deteriorated

chimney loose brick

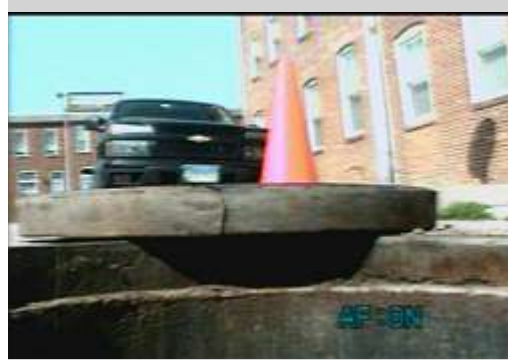
Defect 1

Condition: **Cracked**

cracked cover
